HATHAWAY POND DAM

PHASE I INSPECTION REPORT
NATIONAL DAM INSPECTION PROGRAM

MICHAEL BAKER, JR., INC.

Hathaway Pond Dam, Susquehanna County, Pennsylvania
NDI No. PA 00050, PennDER No. 58-06
West Branch of Lackawanna River
Inspected 30 October 1980

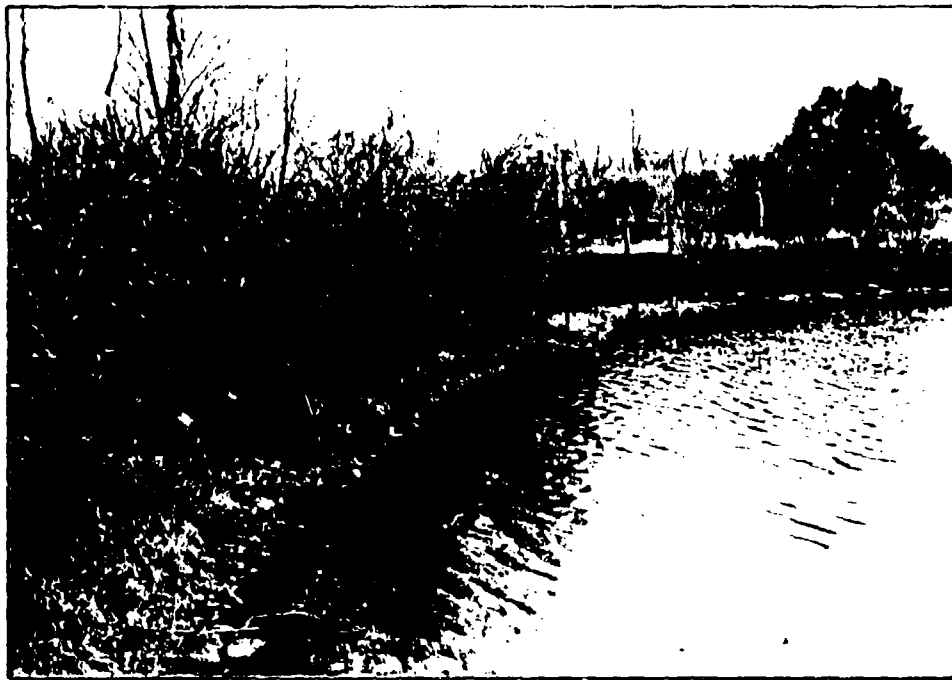
Overall View of Left Upstream Side of Dam and Spillway

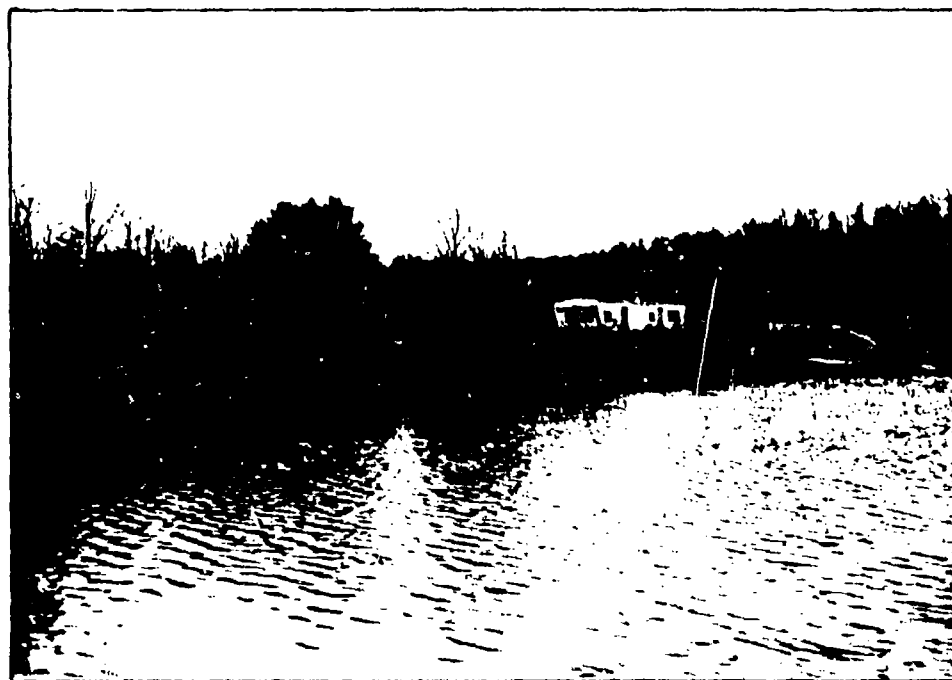
Overall View of Right Upstream Side of Dam

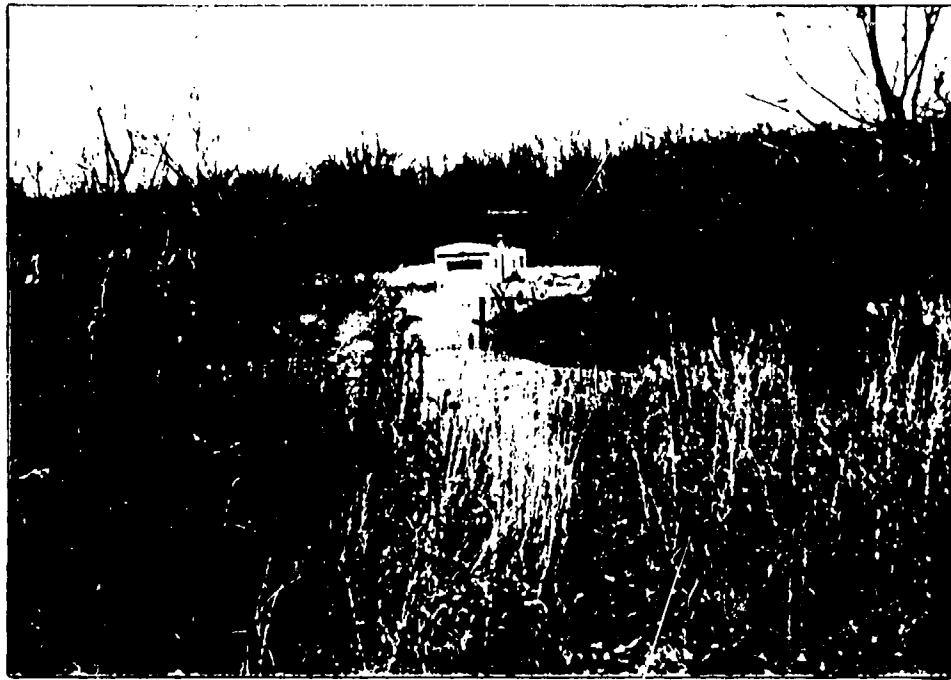
PHOTO 1. View Along Crest of Dam from Left Abutment

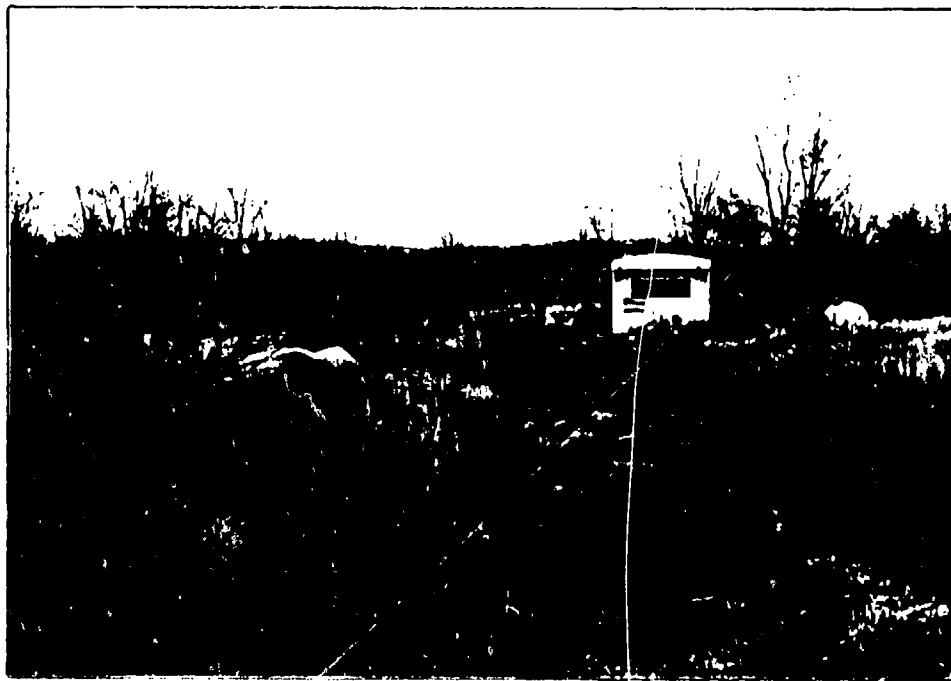
PHOTO 2. View Along Crest of Dam from Right Abutment

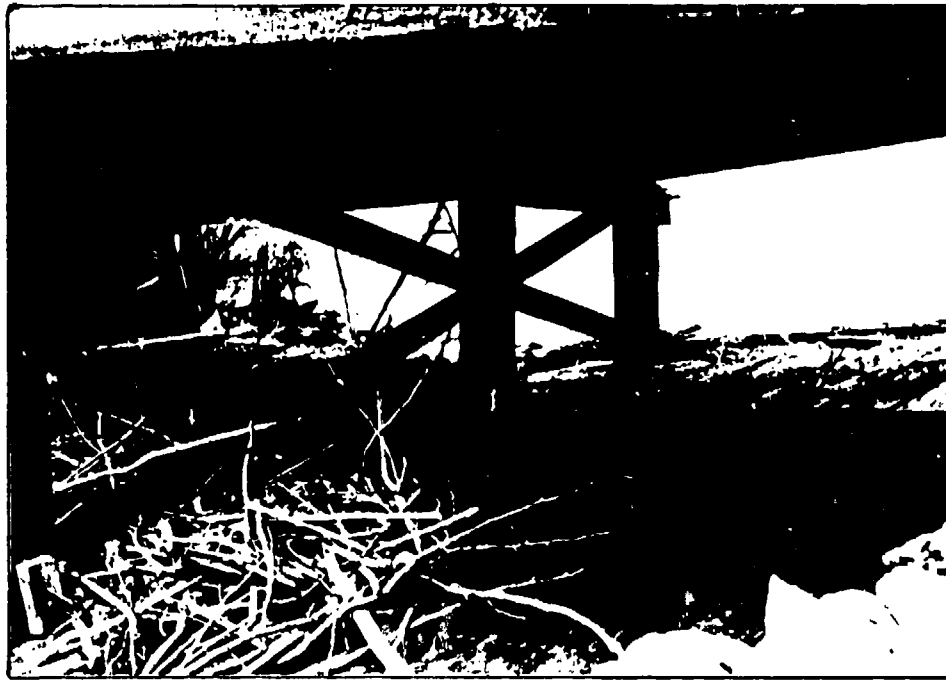
VISUAL EXAMINATION OF	OBSERVATIONS	REMARKS OR RECOMMENDATIONS
CONCRETE WEIR	Rectangular channel spillway is lined with wooden plank sheeting. The sheeting is deteriorated, and debris has collected on the downstream end of the channel.	Replace the sheeting in the spillway and clear debris from the channel.
APPROACH CHANNEL	Good condition	
DISCHARGE CHANNEL	Good condition	
BRIDGE AND PIERS	Bridge over the spillway is in a very deteriorated condition.	Replace bridge.

PHOTO 7. View of Timber Spillway Discharge Apron

- 6) Repair the left spillway training wall.
- 7) Repair the spillway discharge apron and remove the brush and debris from the apron.
- 8) Repair the bridge over the spillway.

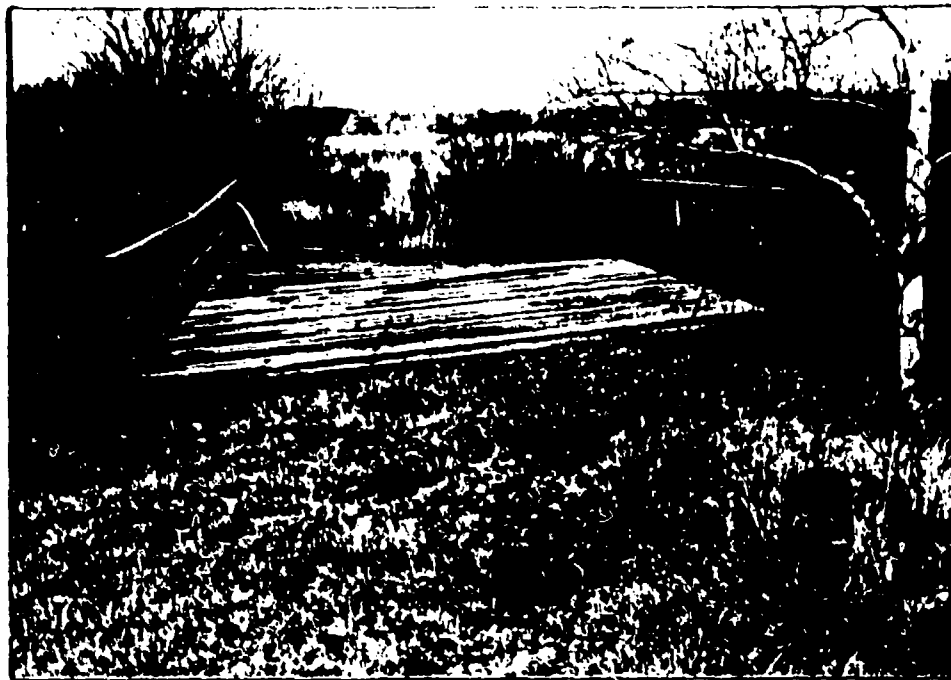
PHOTO 9. View of Top of Wooden Bridge Across Spillway
